Indoor Coil Corrosion Industry Research Report

Introduction

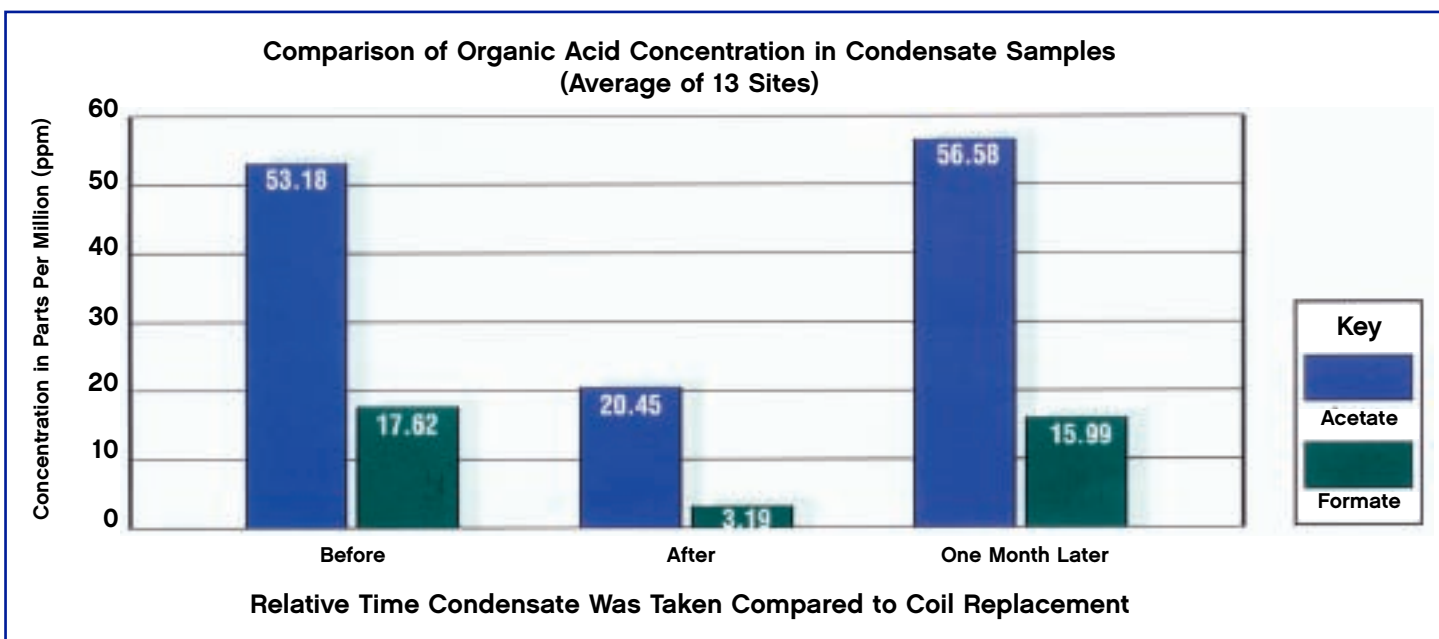
As part of Carrier's efforts to research this problem, coil condensate sampling was performed at coil failure sites. The analysis of these samples confirmed the presence of significant levels of formate and acetate in the household environments. These samples were collected just prior to coil replacement and immediately after the coils were replaced. Additional samples were then taken at some sites during follow-up assessments a month later.

The following chart shows the average trend of acetate and formate levels from 13 sites located in the Houston, Mobile, St. Louis, Indianapolis and Memphis areas. The levels are elevated prior to coil replacement. When condensate is drawn immediately from the new coil, the levels decrease dramatically. Finally, after a short period of operation, the levels return to previously elevated levels. These measurements are also an indication that the corrosive agents are not tied to the new replacement coils because the condensate samples drawn directly off the new coils show decreased levels of acetate and formate. After the coil has been installed for a period of time, the levels of these agents once again reflect the operating environment of the coil. Identifying the sources of agents that cause these failures is certainly a step toward resolving this problem.
